Research Article

## User Accessibility in Shopping Malls: Towards Compliance and Inclusive Design

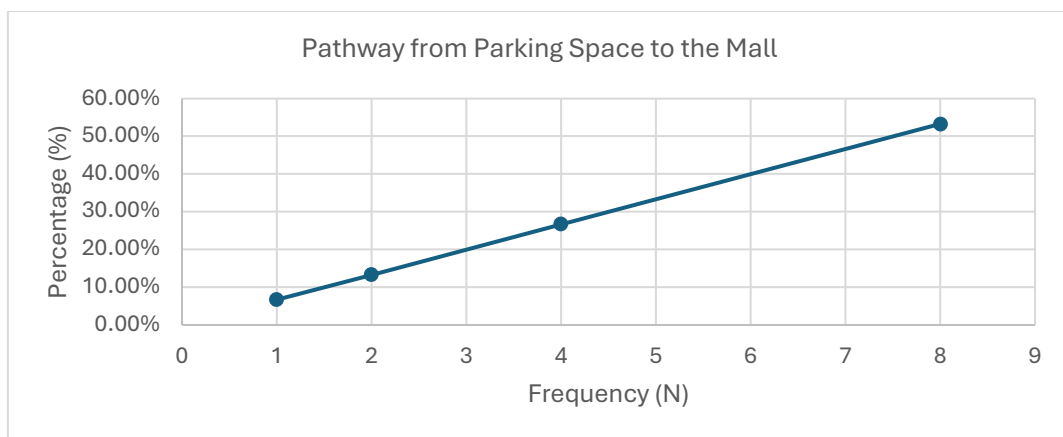
To assess access for individuals with disabilities, elements such as the pathway from the parking area to the mall, interior circulation routes, enclosed parking spaces, pathways to the building, canopies or weather protection devices, a reception area or information desk, double-leaf doors and gates, and self-closing swing doors were observed. It was observed, and it was strongly agreed, that 53.3% of shopping malls possess a pathway from the parking area to the mall, as seen in Figure 2. Accordingly, most malls provide basic external access routes, indicating a general awareness of pedestrian connectivity. However, the 20% dissent highlights inconsistency in design standards across malls.

Figure 2. State of the pathway from the parking space to the malls (Source: Authors).

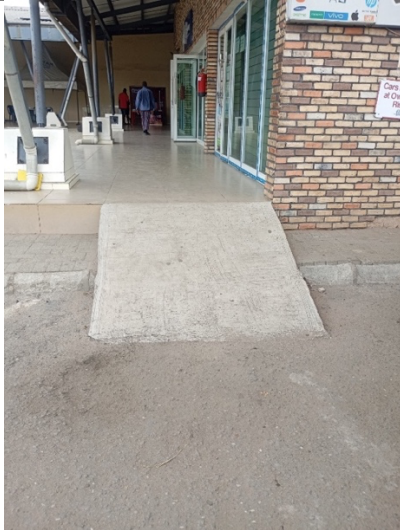
For instance, field observations conducted at Market Square, Orlu Road, Imo State, revealed several deficiencies in accessibility provision. This widespread non-compliance is illustrated in Figure 8, where ramps are constructed without handrails and appropriate slope considerations, thereby compromising safety and usability for persons with disabilities. Furthermore, physical obstructions were evident, as shown in Figure 9, where guard rail configurations restrict movement and reduce effective circulation width for wheelchair users.

Figure 8. 1200mm wide ramp with 7° slope angles positioned without handrails, and signage (Source: Authors).

Section 19 (Ramps) specifies the maximum slope, width, and, importantly, the need for handrails on both sides of a ramp. The "absence of handrails in nearly half of the malls" represents a clear and widespread infringement. Additionally, Section 20 (Stairs) mandates the installation of handrails for safety and assistance. Moreover, Section 21 (lifts/elevators) describes the specifications for lifts as aids for elevation, including lights, call buttons, and interior space. The "high neutrality and disagreement" regarding lighting platforms or elevation aids indicates a failure to meet requirements for accessible vertical circulation. The findings thus reveal that the lack of specific fire escape routes and inadequate signage creates a discriminatory and life-threatening environment for PWDs, violating their right to safety.

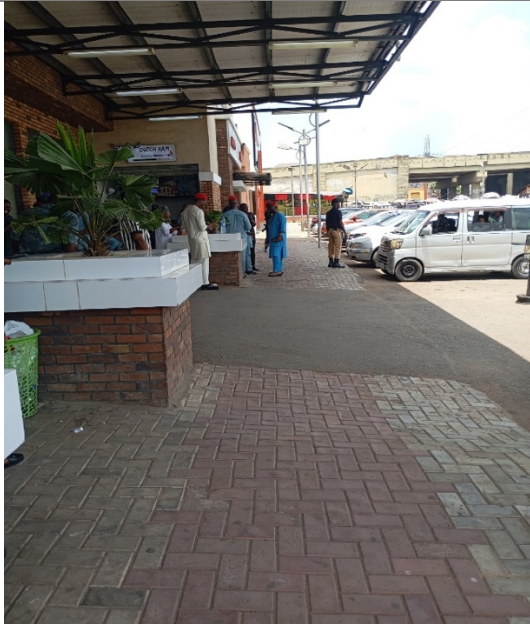
The study also identified additional accessibility deficiencies at Priceless Stores, Okigwe Road, Imo State, where the entrance lacks tactile markings and Braille systems necessary for visually impaired users. Additionally, the mall's external environment lacks fundamental accessibility infrastructure such as zebra crossings, protected pedestrian routes, and designated boarding areas, indicating systemic neglect of inclusive external design.

Figure 14. Entrance porch of the mall devoid of tactile markings and the braille system (Source: Authors).

The presence of "largely absent or underutilised" features indicates a failure to create an inclusive exterior environment. This means that the lack of tactile/Braille signs forms a barrier for visually impaired individuals, making autonomous navigation outside the mall impossible.

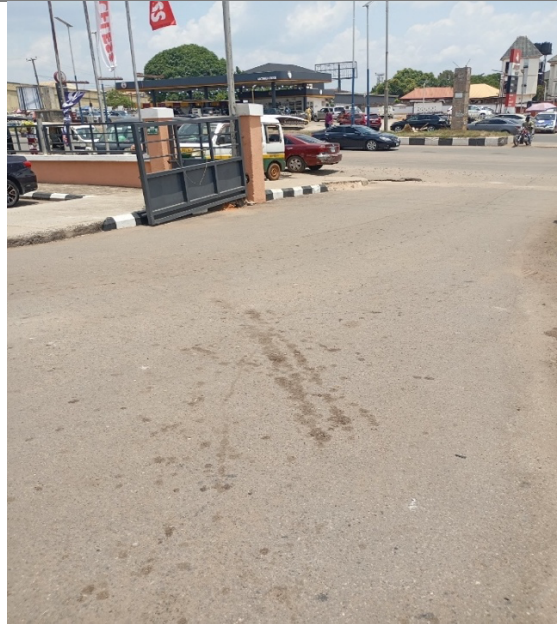
Figure 15. Access point to the mall's exterior environment without a zebra crossing, covered boarding and alighting area, as well as a protected pedestrian bridge, routes, signage, and buttons (Source: Authors).
